**SOHO DVI KVMs
F1DD102U**

**SOHO Dual-Head KVMs
F1DH102U
F1DH104U**

**SOHO Pure USB KVMs
F1DS102U
F1DS104U**

SOHO USB KVM Firmware Update Instructions

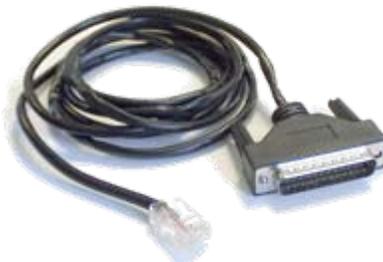
Plug the supplied Firmware Update Cable in to the (DB25) Parallel Port of a stand-alone Computer (i.e. one that is not currently connected to and controlled by the KVM) and connect the other end of the Cable into the (RJ45) Firmware Upgrade Port of the KVM.

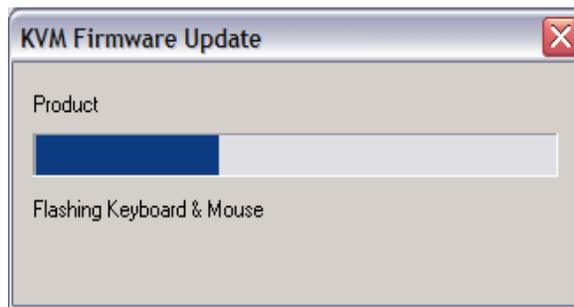
Providing the Flash Upgrade is being performed successfully, you should see a Window with a Progress Bar similar to that shown below.

Once the Firmware Upgrade has been successfully completed an extra Window will appear with a message to this effect. Simply close this Window.
